Quality Assurance and Source Inspection

Contract #: 04-0120F4Cty: SF/ALA Rte: 80 PM: 13.2/13.9File #: 69.28**WELDING INSPECTION REPORT****Resident Engineer:** Pursell, Gary**Address:** 333 Burma Road**City:** Oakland, CA 94607**Report No:** WIR-001120**Date Inspected:** 20-Dec-2007**Project Name:** SAS Superstructure**OSM Arrival Time:** 1400**Prime Contractor:** American Bridge/Fluor Enterprises, a JV**OSM Departure Time:** 2330**Contractor:** Zhenhua Port Machinery Company, Ltd (ZPMC), Changxing Island **Location:** Shanghai, China**CWI Name:** Fu Yu Hong**CWI Present:** Yes No**Inspected CWI report:** Yes No N/A**Rod Oven in Use:** Yes No N/A**Electrode to specification:** Yes No N/A**Weld Procedures Followed:** Yes No N/A**Qualified Welders:** Yes No N/A**Verified Joint Fit-up:** Yes No N/A**Approved Drawings:** Yes No N/A**Approved WPS:** Yes No N/A**Delayed / Cancelled:** Yes No N/A**Bridge No:** 34-0006**Component:** 77 meter mock up assembly**Summary of Items Observed:**

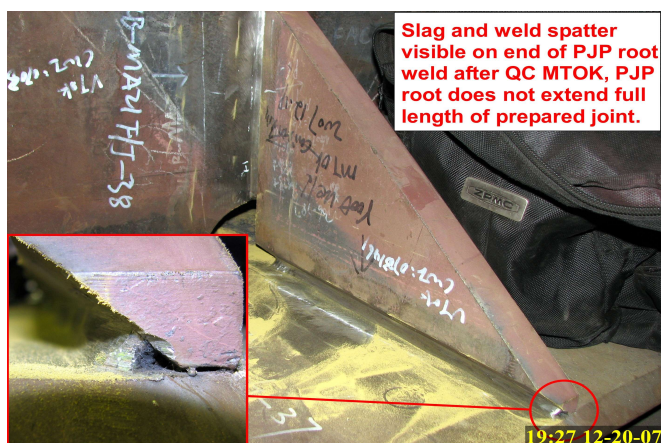
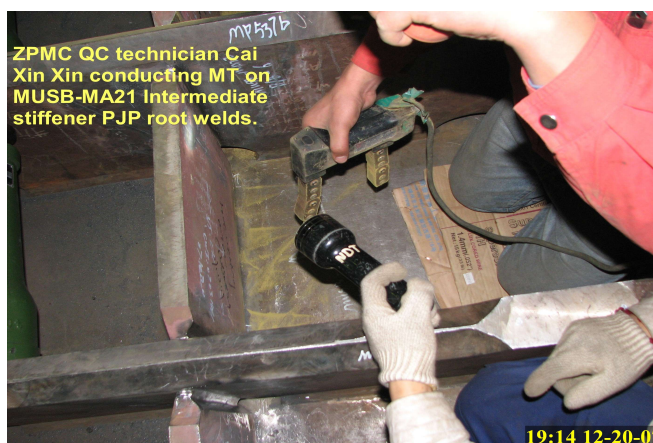
partial joint penetration (PJP) root welds on 89 meter mock up assembly MUSB-MA21 between the intermediate stiffeners and skin plate and/or primary stiffeners. The QA inspector made random observations as the MT was being conducted. The QA inspector noted that several of the root welds are marked "Root MT Acceptable" by the ZPMC technician Cai Xin Xin. The QA inspector noted that several areas on the accepted welds appear to have white paint markings and the QA inspector observed ZPMC workers grinding these areas after the MT inspection has been conducted. The QA inspector also noted that the PJP root welds do not appear to extend the full length of the prepared joint length. See the attached photos of these observations.
